Docket No. 217 – Development and Management Plan Inspection

Northeast Utilities Service Company Certificate of Environmental Compatibility and Public Need for the construction of a 345-kV electric transmission line and reconstruction of an existing 115-kV electric transmission line between Connecticut Light and Power Company's Plumtree Substation in Bethel, through the towns of Redding, Weston, and Wilton, and to the Norwalk Substation in Norwalk, Connecticut.

Date: September 29, 2005

Location: 345kV Underground Route

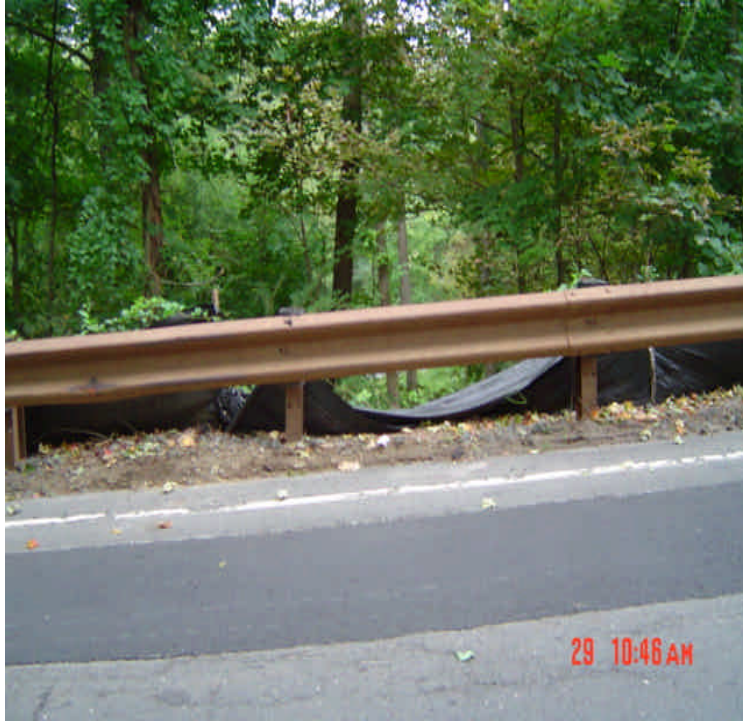
345kV (Route 107 Daywork): The photo on the left shows some silt fence beginning to come down near Blueberry Hill Rd. The photo on the right shows a storage area on Umpawaug Rd. where silt fence is down and a pile of soil is not within controls. (9/29/05)

Areas of Inspection	Observation	Recommended Action
<p>Erosion and Sediment Controls (continued)</p> <p>Rt. 107 Daywork</p>	<ul style="list-style-type: none"> - Catch basins are still not being protected consistently on this portion of the work. BSC did not note any protection measures on catch basins in this area during this inspection. 9/21-9/29/05 - An area of silt fence in the work area just off Rt. 107 on Umpawaug Rd. was still down due to placement of materials and equipment. Soil stockpiled here is also not enclosed. 9/7-9/19/05 - Materials had been cleaned up from over the guardrail in previous work areas. 9/29/05 - It needs to be confirmed whether the disturbed soil on the side road north of Georgetown Deli was stabilized. 9/29/05 - A section of silt fence near Blueberry Hill Rd. was beginning to come down but still appeared to be toed in and functioning. 9/29/05 	<ul style="list-style-type: none"> - In general, catch basins should also be cleaned regularly and roadways swept of sediment attributed to the project. Contain all muds and monitor where water is flowing even when catch basins are not the receivers. 9/29/05 - The fence here should be restored. 9/7-9/29/05 - Continue to provide good “housekeeping” and in general materials should be placed in storage areas and contained with the work. 9/15-9/29/05 - Either mulch and seed the disturbed soil or place silt fence up at this location if not already done so. 9/29/05 - Repair and maintain silt fence as necessary. 9/29/05

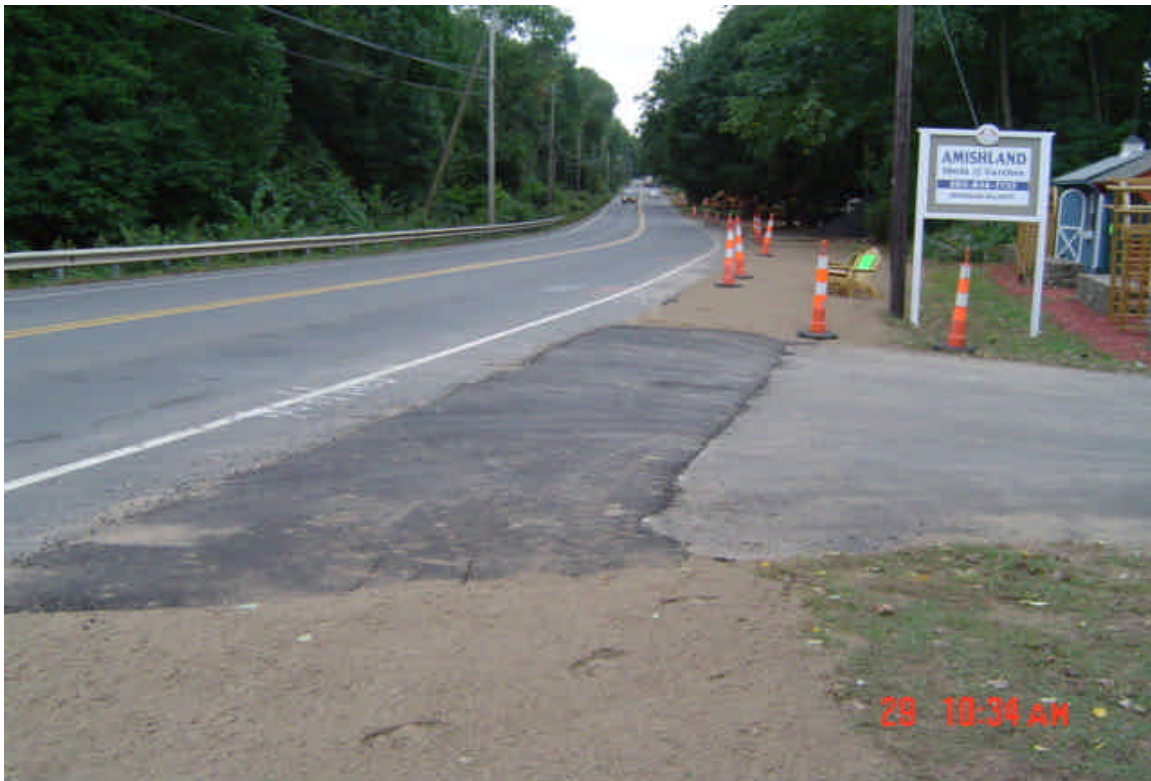
345kV (Route 7): View of trenchwork in lawn areas that have been seeded and restored. (9/29/05)

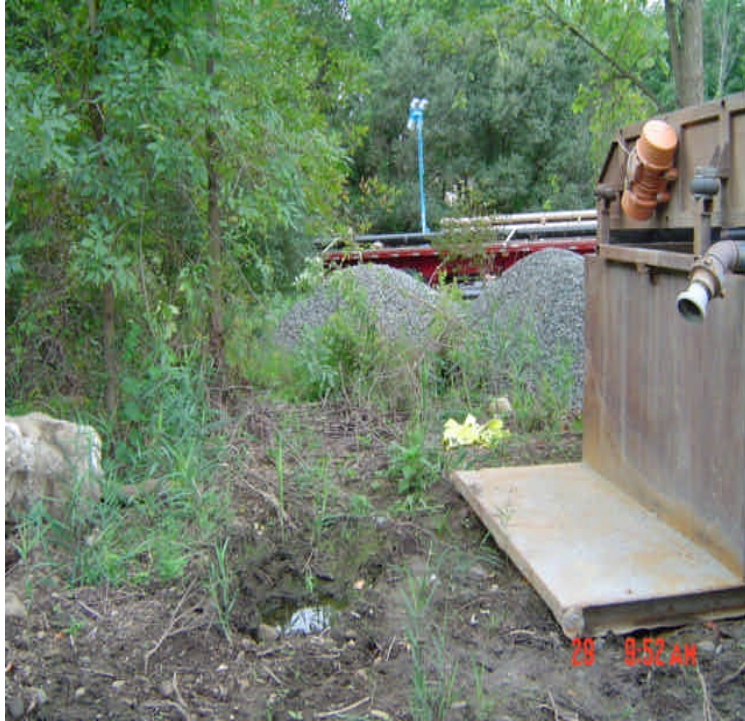
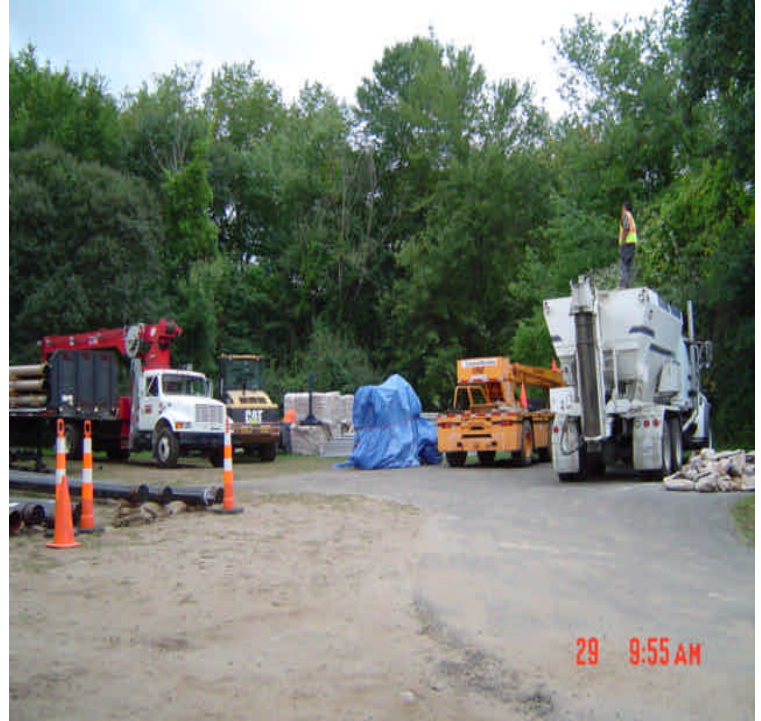
345kV (Route 7): Photo on the left shows the School Rd. area storage yard with equipment and materials placed close to the brush line. Attempt to contain yards as much as possible and use silt fence as a work limit if necessary. Photo on the right is another view of the equipment stored at the yard. 9/29/05

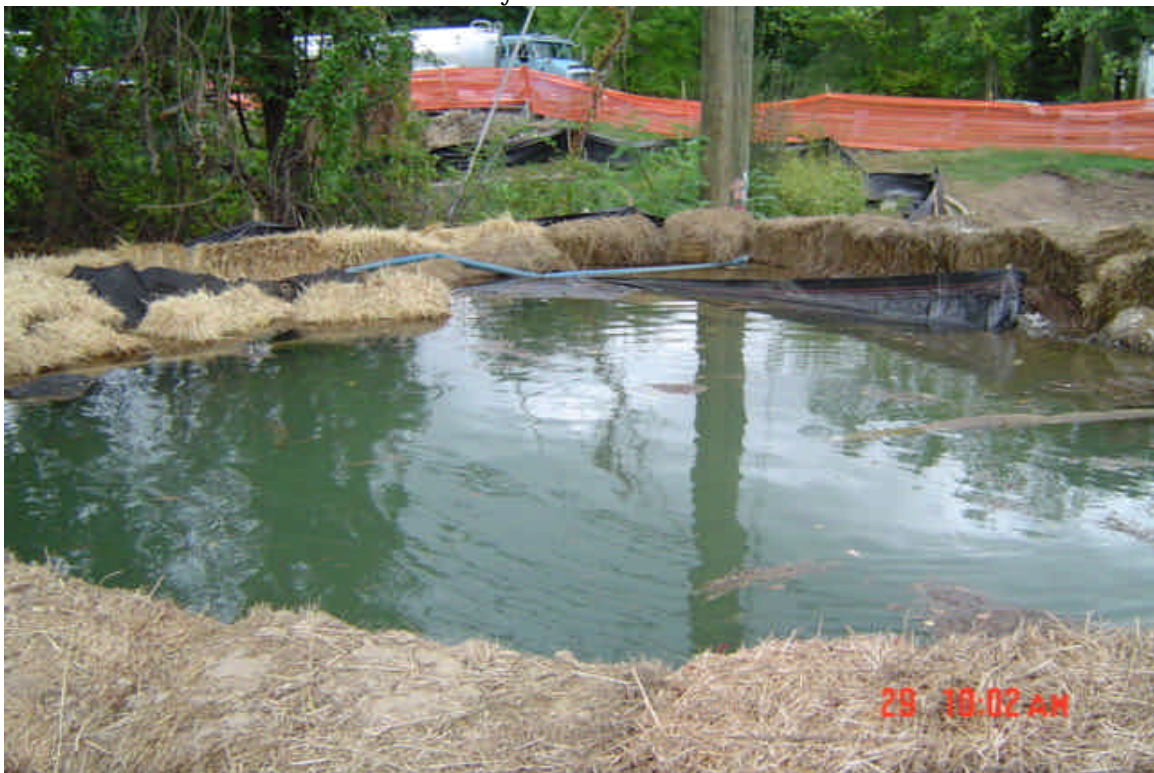
The settling basin at the jack and bore is in good shape with much improved water clarity and erosion controls. (9/29/05)

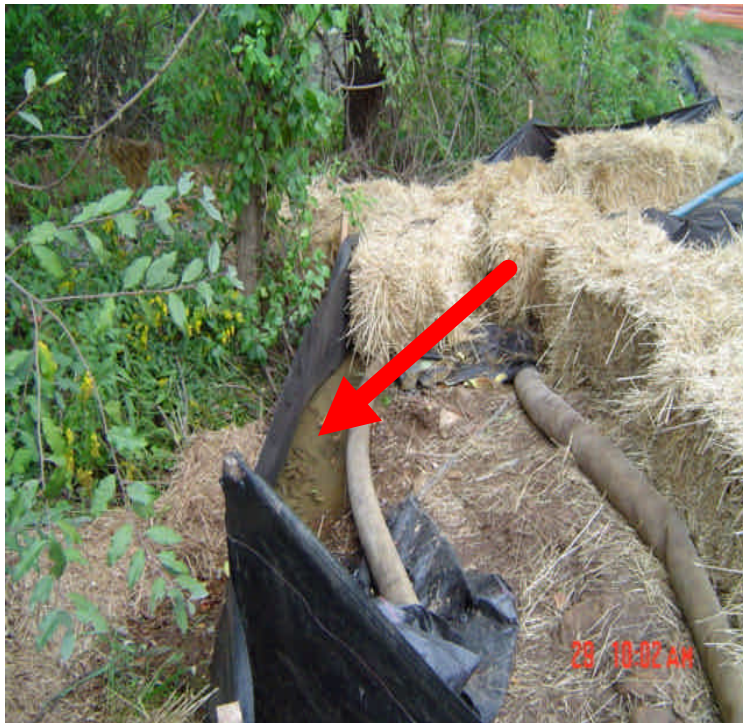
Photo on the left shows how the silt fence is working well to collect and filter the water discharging from the basin. The photo on the right shows the improved clarity of the stream water where it reaches the last barrier. (9/29/05)

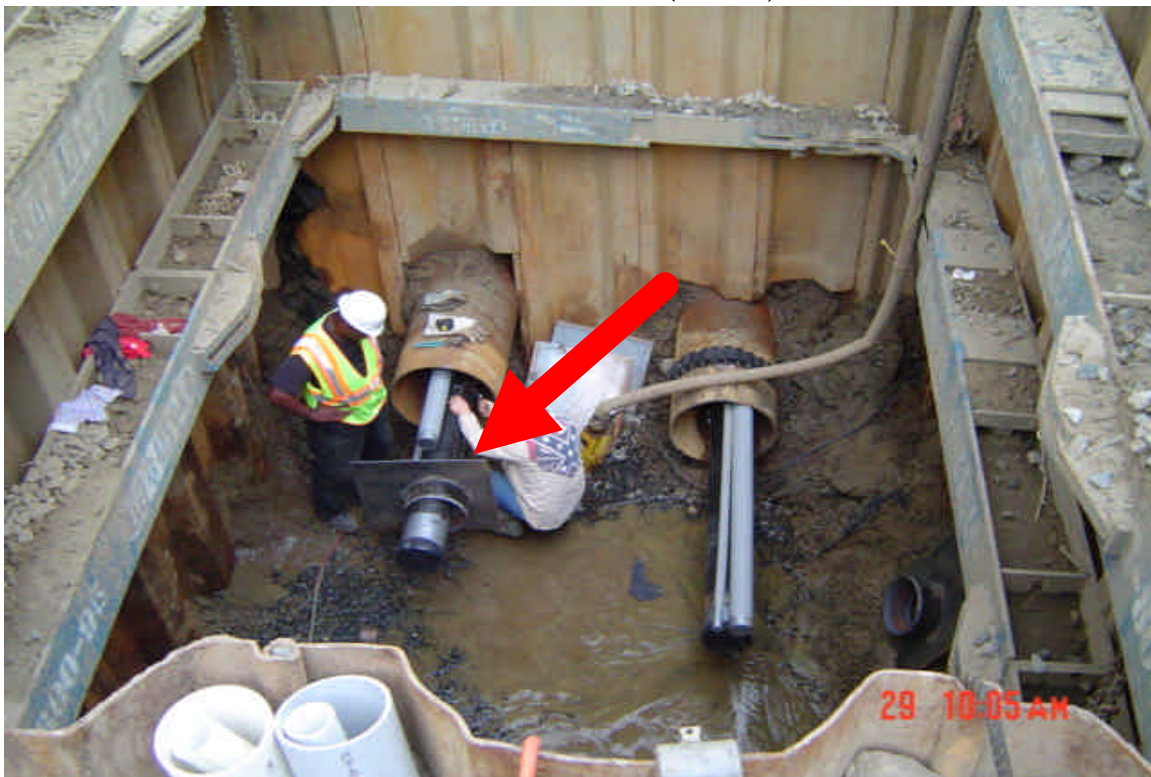
View of activity in the receiving pit to bring the HPFF pipe through the conduit installed under the stream. (9/29/05)

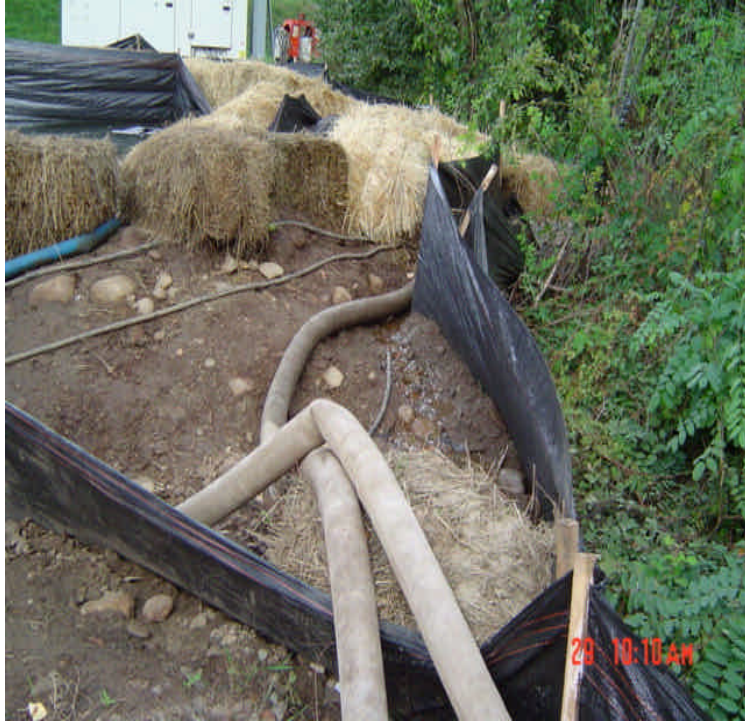
Photo on the left shows where a small leak of water is escaping through the silt fence corner at the bottom right of the picture. The photo on the right shows a section of silt fence that needs to be toed in on the northern side of the stream. (9/29/05)

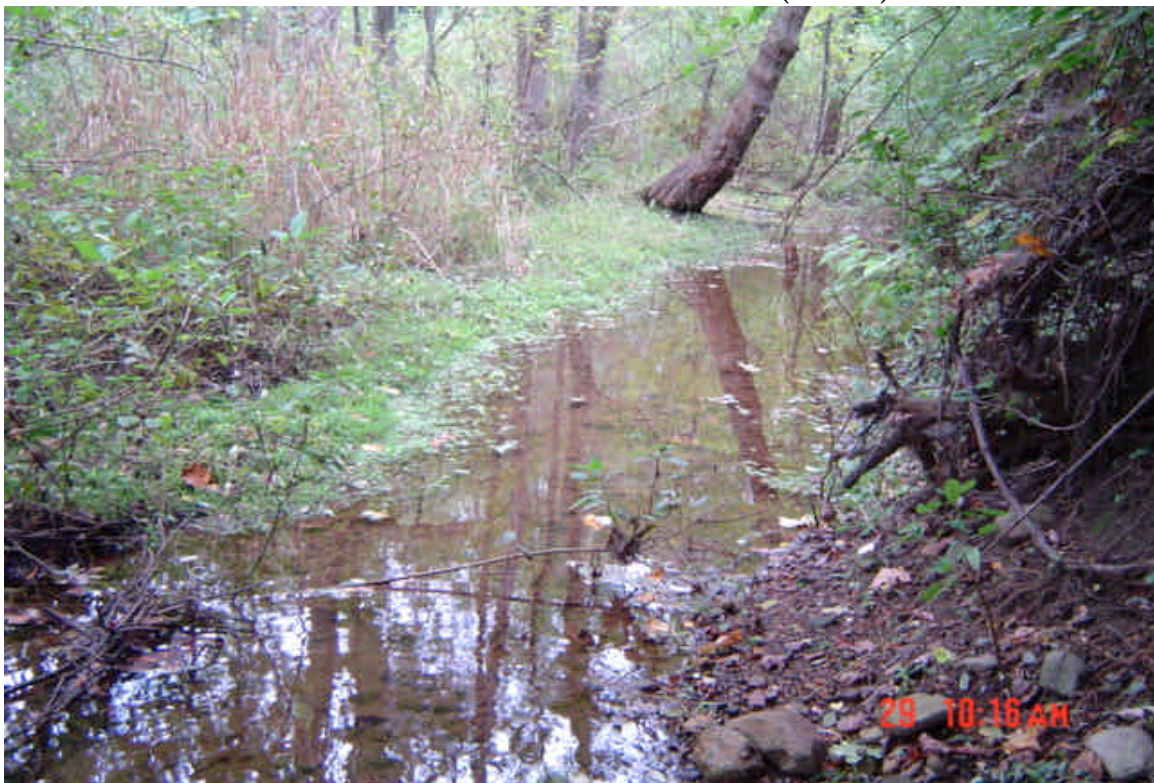
<p>Adjacent Wetlands and Waterways</p>	<ul style="list-style-type: none"> - At the jack and bore near Allens Meadow Park, the water clarity of the stream was improved due to the repairs to the controls here.. Obvious deltas of sediment were not noted downstream of the culvert but fine sediment was on the stream bottom. 9/29/05 	<ul style="list-style-type: none"> - BSC can continue to help delineate areas of sediment that should be removed by hand. 9/29/05
<p>Staging, Storage, and Parking Areas</p>	<ul style="list-style-type: none"> - The silt fence at the equipment storage yard located on property off Rt. 7, south of the Rt 107 and 7 intersection has been completely pushed over by separate landowner activities. 	<ul style="list-style-type: none"> - The fence is not yet repaired but should be as a limit of work. Wetlands are located immediately adjacent. 8/19-9/29/05

View of the stream downgradient from the work (across Rt. 7) with fairly clear water and no apparent deltas of sediment. However, fine sediment was observed settled out on the bottom. (9/29/05)
